Failure Analysis on Conveyor Chain Links of a Central Bucket Elevator

E. Yin, J. M. Kihuu, O. M. Muvengei, K. Njoroge

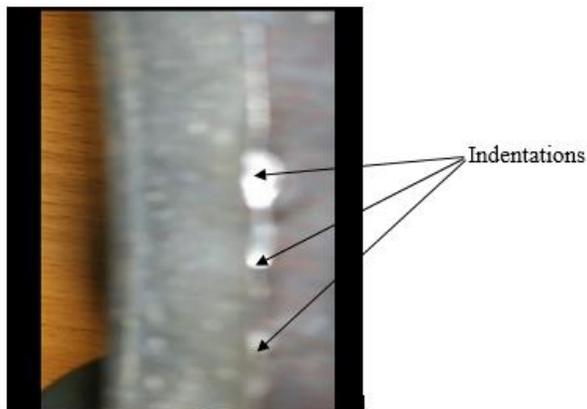
The preliminary examination done on the factory site revealed indentations on the chain links which is as a result of the sprocket impacting on the chain link as shown in the figure below.

Fig. 5 Indentations on Chain Link

This indicates misalignment and vibrations within the bucket elevator system. Examining the sample under the stereo microscope revealed that the grains at the fractured surface were fine pointing to the fact that it's a brittle fracture.

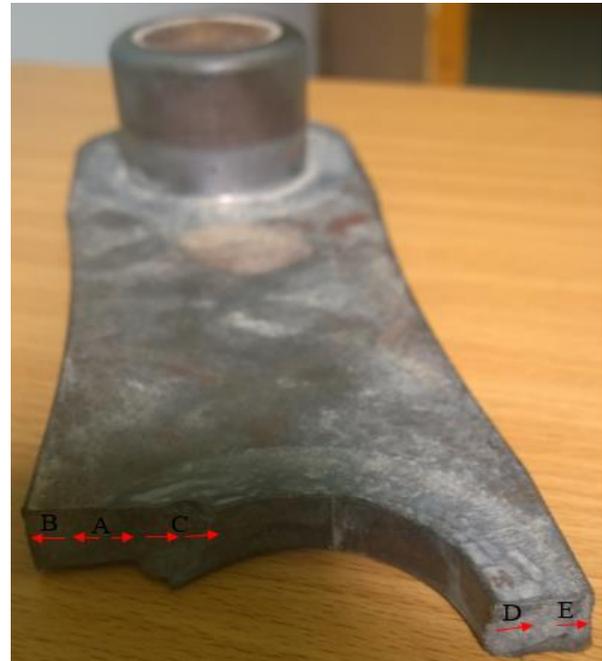
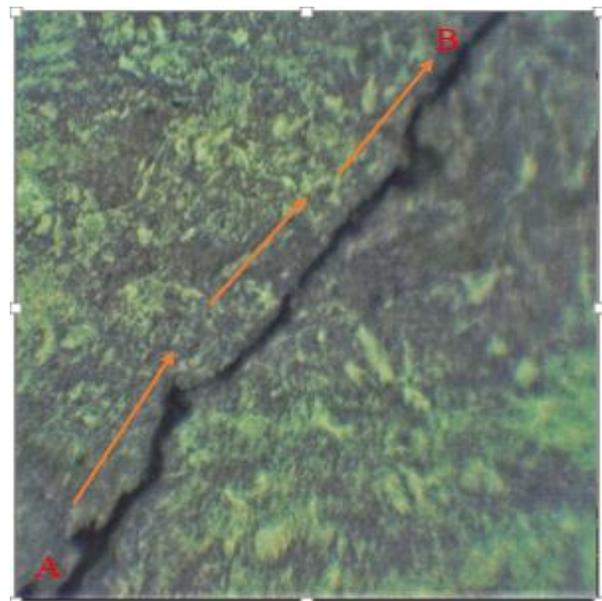
Fig. 6 Fracture Mechanism

Also the mechanism of failure was obtained by tracing the chevron mark on the surface. The fracture started from the core of the fractured surface B of the link and proceeded until it snapped i.e. A → B → C → D → E. The mechanism of

failure is as shown in the figure 6. Figure 6 (a) shows that the crack begun at point A and progressed gradually to the surface at point B. Since the chain link is under tensile loading and the crack had already been initiated at A and grown to B, it then progressed from C to D and finally fractured at E. The initiation and growth of the crack from A to B is as shown in Figure 6 (b)

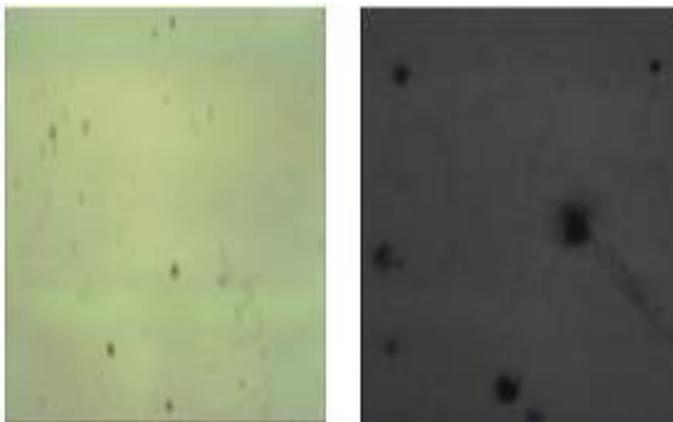
After polishing of the samples was completed, it was viewed under light microscope both etched and unetched. The unetched polished sample showed a lot of blow holes which is a casting defect as shown in figure 7 (a) and oxide formation within the material as shown in figure 7 (b) within the material as shown in the figure below;

(a) (b)
Fig. 7 Blow holes and oxide formation

The type of oxide will be determined by using SEM equipped with Energy Dispersive X-Ray (EDX) to verify if the oxide is detrimental to the steel material or not. The polished samples was then etched in an etchant made of 98% methanol and 2% nitric acid (Nital). The microstructure was observed as in the figure below;

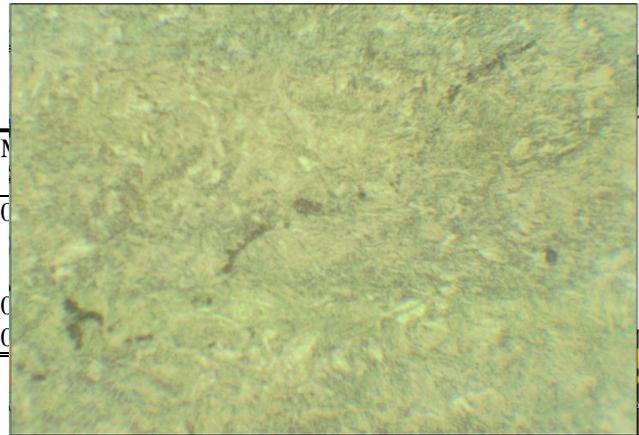
Fig. 8 Microstructure

The micro structure is martensitic which accounts for high strength and wear resistance because of its application. From the micro structure it can be deduced that the material has undergone heat treatment. The micro structure showed a lot of existing cracks within the material introduced during manufacturing as shown in the fig 9. These cracks then propagated during loading leading to the eventual fracture of the material.

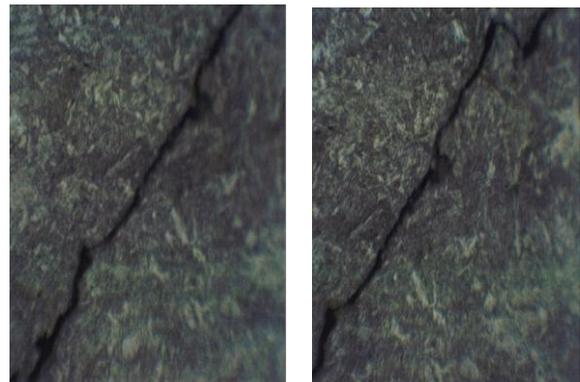
Fig. 9 Cracks within material

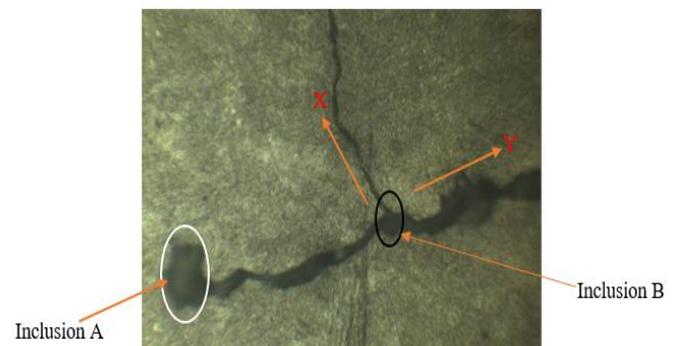
The crack began from inclusion A and progressed until it reached inclusion B. From inclusion B, two cracks emerged, one in the direction of X and the other in the direction of Y as shown in the figure 10.

Fig. 10 Crack initiation

These cracks had initiated from an inclusion as shown in figure 10 under magnification of 500x. Inclusions are produced when the quantity of metal added is greater than necessary to kill steel. The remaining metals combines with oxygen to form inclusions. The metal usually used in killing steels is aluminum. Inclusion are known to have low formability and during loading they produce cracks in the steel. Since inclusions cannot be eliminated completely from steels it is imperative to modify them in terms of chemical composition to minimize their harmful effect with calcium so they become harmless. Calcium (modifier) addition is therefore the solution to eliminating these inclusions by chemically reacting with the inclusion to form calcium aluminate. Calcium aluminate improves machinability, toughness and surface quality rather than being a crack initiation point.

It is recommended that calcium should be added to the steel to eliminate the inclusions by so doing existing cracks will be eliminated. Also the carbon content should be modified to meet the required standards.
