Causes of Surface Cracking in Jointed Plain Concrete Pavement: Case study of Kagere Munyange-Njigari-Gituiga Road in Kenya

James N. Mwitari^{*1}, James W. Kaluli² and Charles K. Kabubo²

This study focuses on the Kagere-Ndunyu-Gituiga Road in Othaya, Nyeri County. The road is made up of Jointed Plain Concrete Pavement (JPCP) slabs. The slabs manifested considerable surface cracking within two years after construction. This study was undertaken to determine the impact of subgrade quality on pavement surface cracking and identify other possible causes of surface cracking in the experimental road.

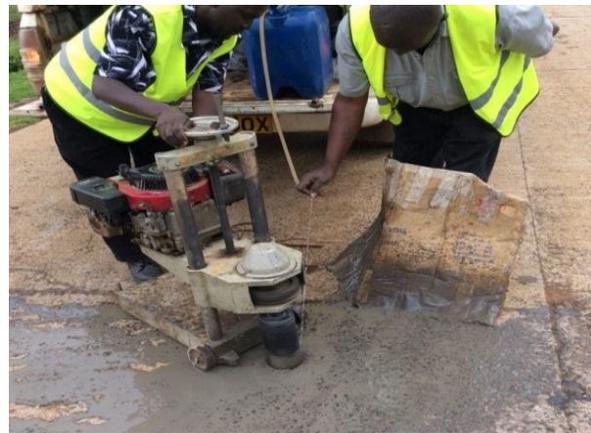
Fig. 4. Core cutting process on concrete slab

Concrete cores were extracted from the concrete slabs through coring using a concrete cutting machine as shown in Fig. 4. Core length (slab thickness) was measured and data recorded in Table 1. The cores which had a standard diameter of 100 mm were then tagged, put in polythene bags, and transported to the laboratory where they were trimmed to size as shown in Fig.5 and crushed in a concrete compressive machine. The highest compression load before the concrete core crushed was recorded and the maximum crushing strength in N/mm² computed by dividing the crushing load in newtons (N) against the core surface area (mm²)

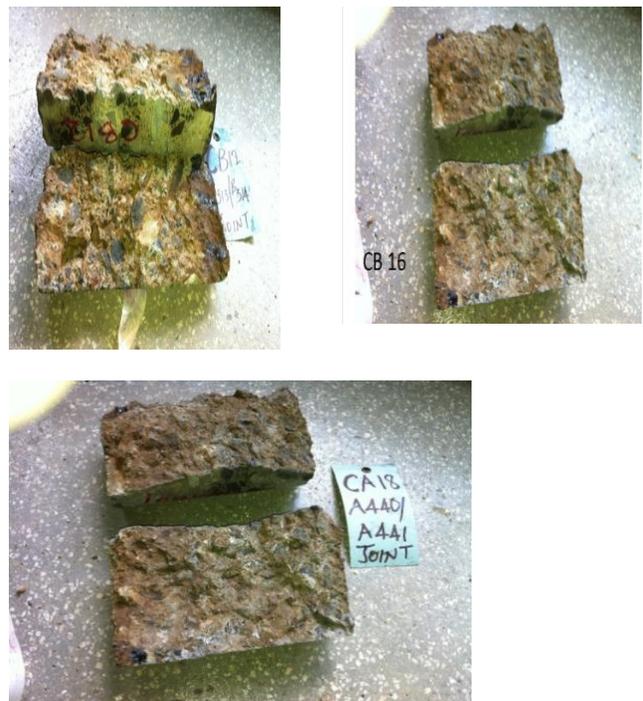
Fig. 13. Full saw-cut-joint crack development for cores CB12, CB16 and CA18

Despite not meeting the recommended saw-cut joint depth, 37.5% of the cut joints induced full depth cracks at the cut joints (Fig. 13, Table 6), some 62.5% of the joints did not develop cracks as intended. The surface cracks that developed occurred at varying distances from the cut joint (Fig.14).

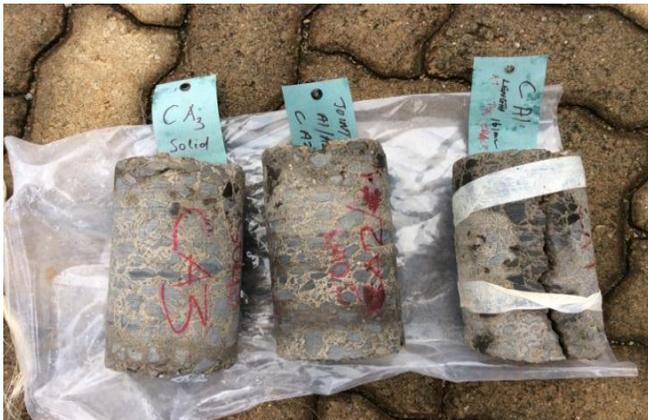
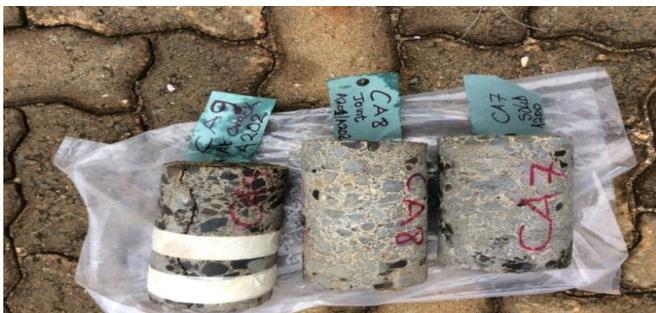
Fig. 14. Photographic presentation of cores CA1, CA2, CA3 and cores CA7, CA8 and CA9 and respective diagrammatic representation of where they were abstracted on concrete pavement slabs.

The saw cut joints were significantly shallow and the specifications on saw cut joints depth were not adhered to. Concrete pavement slabs developed many undesired surface cracks.
